Case study – Compressor rubbing and looseness diagnosed from protection system flight recorder

Application Note

Innovative flight recorder condition monitoring architecture eliminates networks and servers yet allows detailed diagnosis of oxygen compressor rubbing and looseness from 8000 km away.

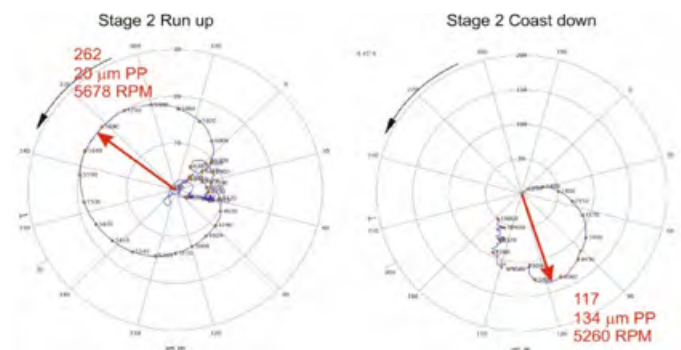
Transient data obtained during the shutdown was first examined. The MDS engineer immediately observed that there was a marked change in the first resonance amplitude and phase (Figure 2) compared to a normal run-up (there was no normal shutdown for comparison).

This change in resonance could be caused by either a change in the system mass (e.g., a broken impeller blade) or a change in system stiffness.

Typically, it is a change of stiffness that occurs, and this is most often due to a seal rub. A decrease in the rotation speed at which the first resonance occurs is indicative of a decrease in the overall system stiffness.

This can be the result of seal clearances opening up, but can also be caused by other looseness in the rotor system.

Figure 2. 1x polar plots from the stage 2 X-probe during a normal run-up (left) and during the ensuing coast down (right) after the compressor tripped due to high vibration amplitudes on the stage 1 and stage 2 probes.

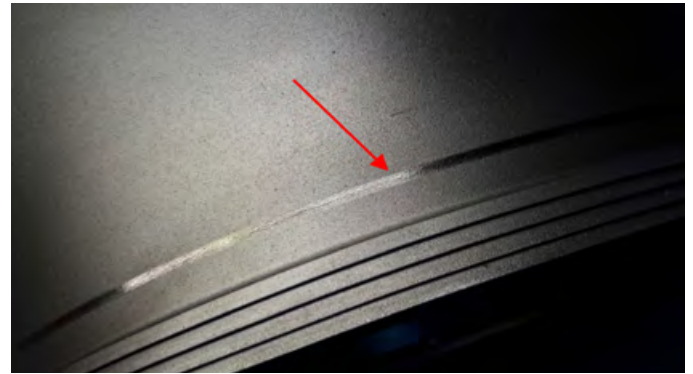
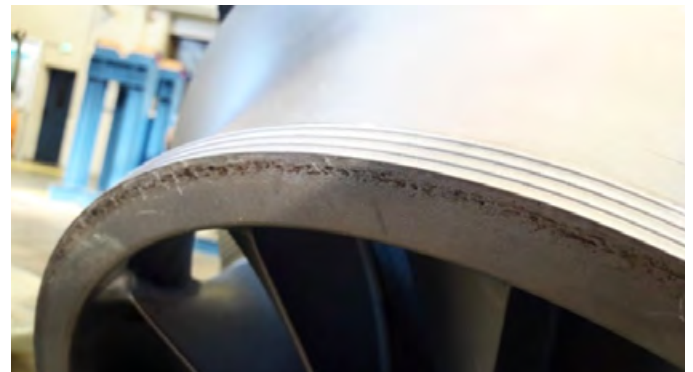
Upon examination of the rotor, impeller, and seals, it was also obvious that a seal rub had indeed occurred. Evidence of the rub was found on the impeller shroud face, axially and radially, for both stages 1 and 2 (Figure 3).

It was further hypothesized that this rub was most likely caused by a loose connection between the impeller and pinion shaft. This was corroborated by the observed condition of the serrated connection teeth on both the impeller and shaft (Figure 4).

Figure 3. 1x polar plots from the stage 2 X-probe during a normal run-up (top) and during the ensuing coast down (bottom) after the compressor tripped due to high vibration amplitudes on the stage 1 and stage 2 probes.

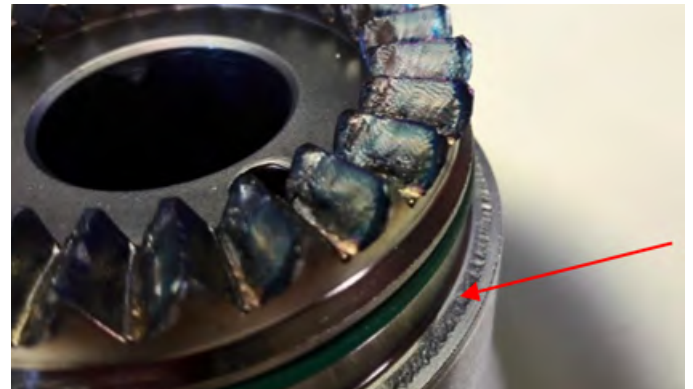
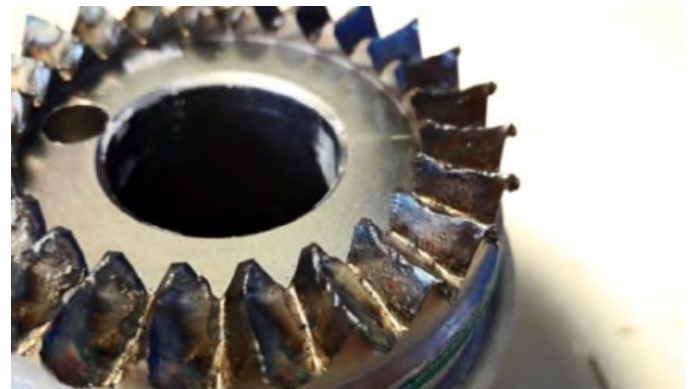
Looking at the connection serration teeth from the shaft and impeller, it can be assumed that the impeller bolt connection holding these components together was loose so the impeller was free to move both radially and axially on the shaft. This consequently resulted in high vibrations, seal leakage, and all of the damage observed on the stage 1 and 2 components.

Figure 4. Serration teeth on the impeller for stage 1 (top) and stage 2 (bottom).

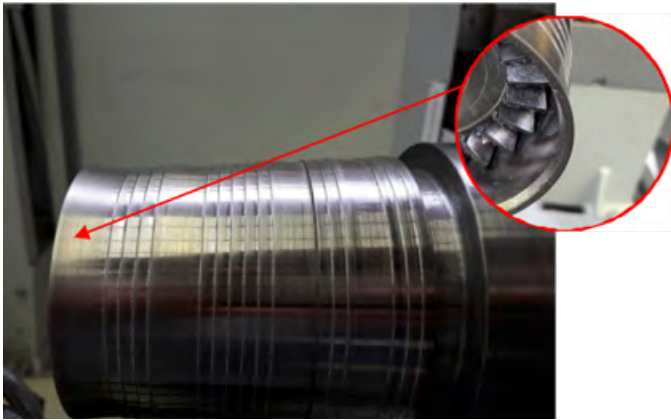
There was also observed plastic deformation at the end of the labyrinth seal sleeve where the sleeve end circumference was enlarged (Figure 5). This enlargement almost certainly affected the seal seating, resulting in a seal leak. The plastic deformation was presumably caused by movement of the impeller on the shaft.

Figure 5. Widened circumference on the mouth of the labyrinth seal sleeve for stage 1 (similar for stage 2).

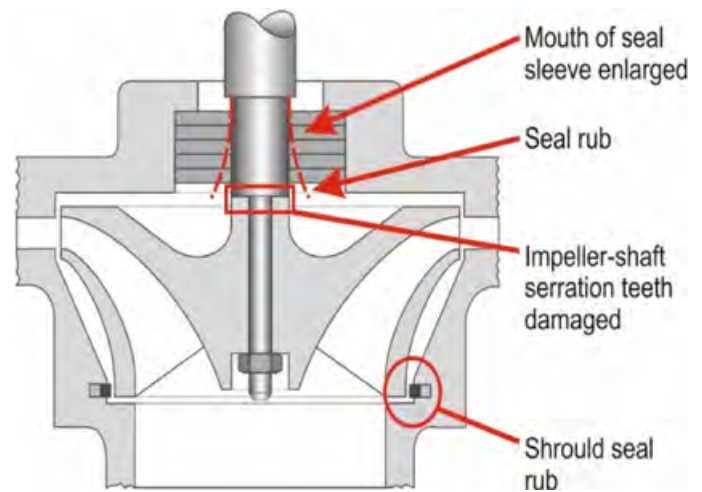
Figure 6. Graphical illustration showing the areas of damage to the stage 1 and 2 portions of the compressor.
