Diagnostic service with the VIBROPORT 8000 in a combined cycle plant

Case Study

Combined cycle plant gas turbines overhauled

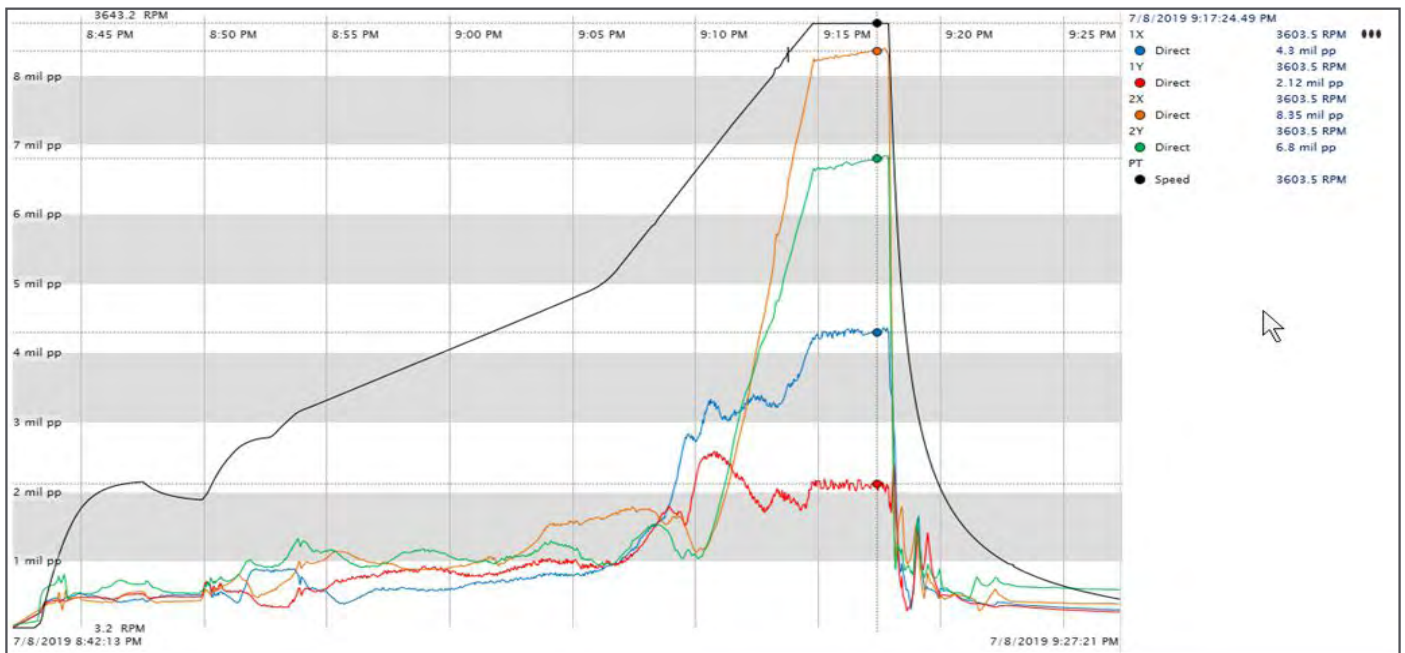
Figure 4. Initial post outage start-up for the gas turbine showing vibration trend during second start-up.

The VIBROPORT 8000 provided shaft centreline, orbit, and frequency spectrum plots during the second start-up (Figure 4).

- There is an indication from the plots that there was continuous contact hard rotor rubbing, i.e., a complete 360-degree rub. This could be the inner stage seal rubbing and possibly also blade tip rubbing.
- High rotor unbalance was evident, but it was not likely the result of rubbing-induced rotor bowing.

- Use a borescope to find evidence of blade and seal rubbing issues.
- Review all blade mass-moment weight and sequencing results.
- Verify installed blade sequencing matches calculations.
- Verify installed seal clearances.

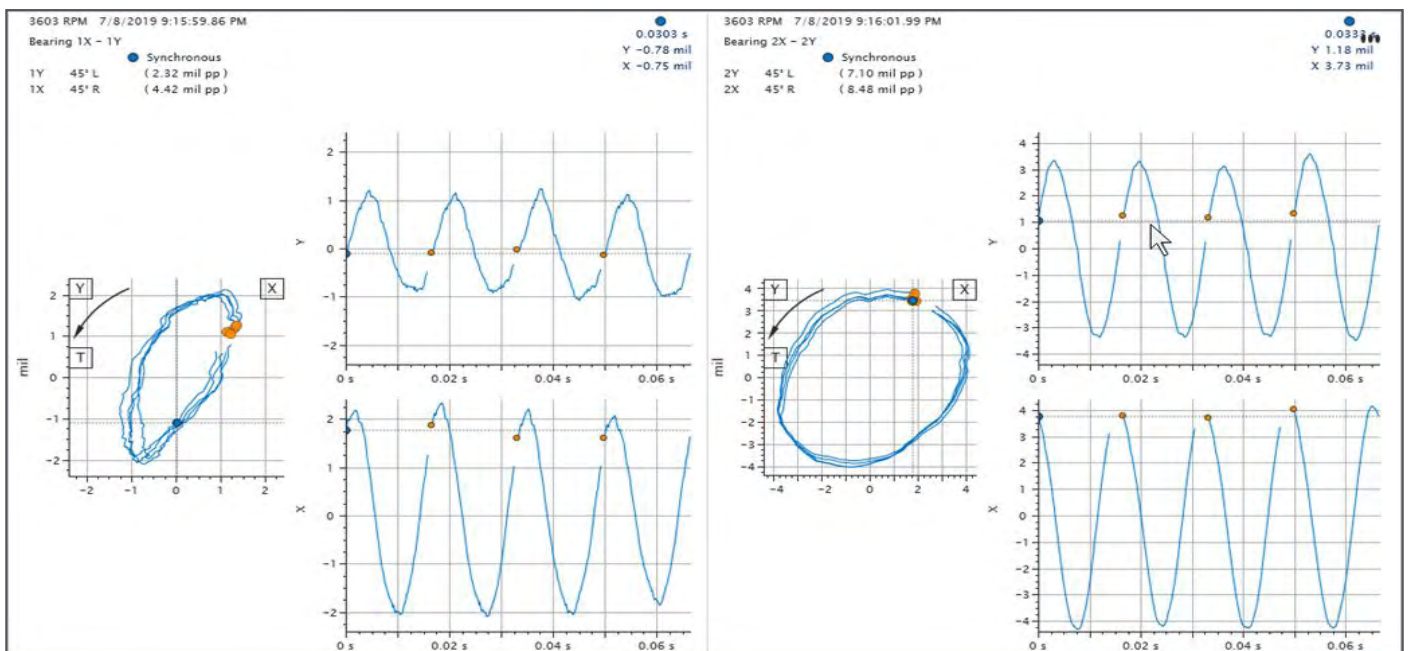
Figure 5. Orbit pots on the gas turbine inlet bearing (left) and the exhaust end bearing (right).

- The orbit plot for the exhaust end of the gas turbine was flattened, while that for the inlet end was more open and with a larger amplitude. Both were forward precessed (see Figure 5).
- High amplitude second balance resonance, i.e., critical speed (not shown).
- Second resonance occurs at a higher frequency than normal for 501F units.
- Little change in slow roll conditions between cold start-up and warm coast-down.
