Case study – Compressor rubbing and looseness diagnosed from protection system flight recorder

Application Note

Innovative flight recorder condition monitoring architecture eliminates networks and servers yet allows detailed diagnosis of oxygen compressor rubbing and looseness from 8000 km away.

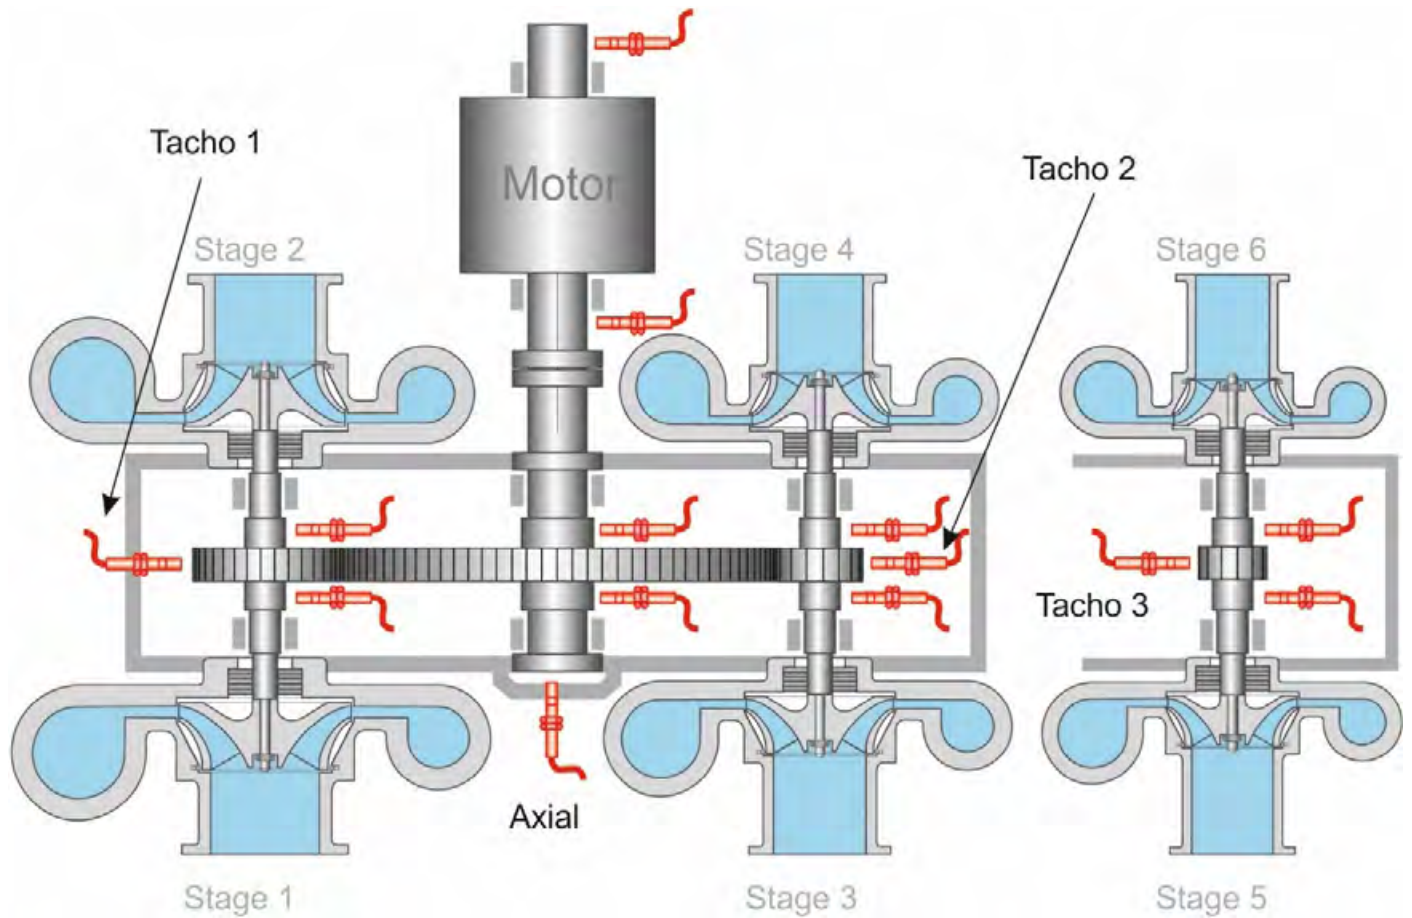
Figure 1. Sensors used for monitoring the compressor. An X-Y sensor configuration is used for all radial displacement sensors. Individual phase reference sensors are used at each of the three pinion shafts for making phase and speed measurements, as all turn at different speeds.
