Diagnostic service with the VIBROPORT 8000 in a combined cycle plant

Case Study

Combined cycle plant gas turbines overhauled

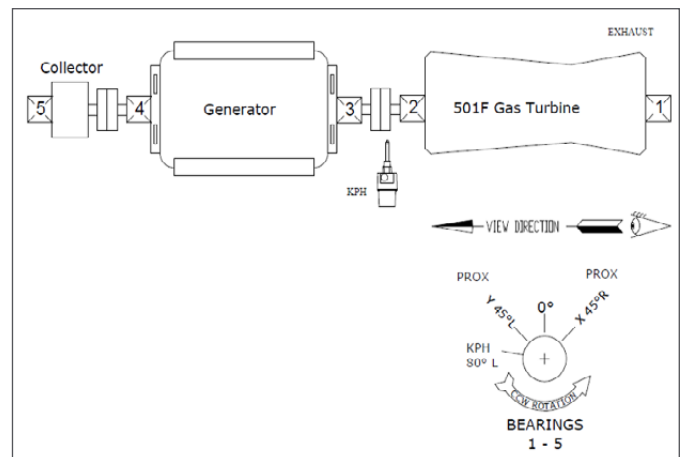
Figure 2. First gas turbine train in the case study combined cycle power plant.

The 501F gas turbines, installed in 2008, had accumulated 400 starts and 80,000 hours at the time of an outage for an overhaul and to be upgraded from 150 to 160 MW. New compressor blades, new inter-stage seals, new bearings, and an upgraded control system were installed.

The first gas turbine fired up for testing tripped within one half-hour during unloaded run-up to speed, so a B&K Vibro diagnostic specialist was called in to find the problem and determine if the turbine could be restarted. A start-up was initiated to collect data using the B&K Vibro multi-channel portable analysis system, VIBROPORT 8000 .

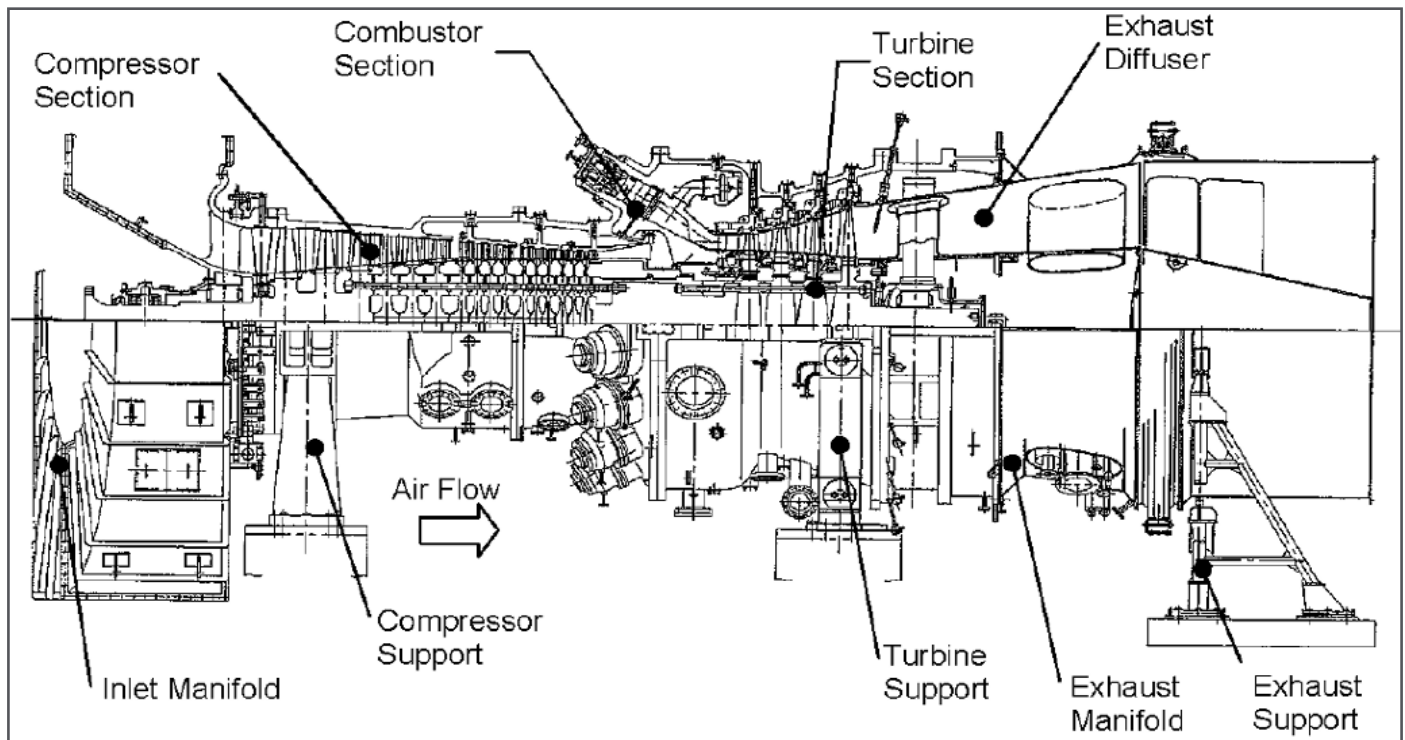
Figure 3. Cross section of the 501F gas turbine.

Maintenance work after the analysis confirmed the diagnostic results, showing that the seals were improperly installed and there were miscalculations in the blade sequencing, despite the fact that the paperwork for the blade mass-moment and sequencing stated everything was in order regarding balance.
